Manhole Inspection Summary

Manhole # S11S__018MH

Insp Date: **3/28/08 9:38 AM**

Location Address: **800 Desoto RD**

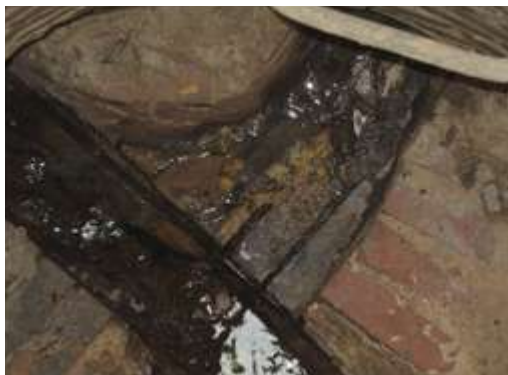
Condition: ☐ Sound ☐ Cracked ☐ Root Intrusion ☐ Deteriorated ☐ Leaks ☒ **Debris**

channel debris/ worn channel

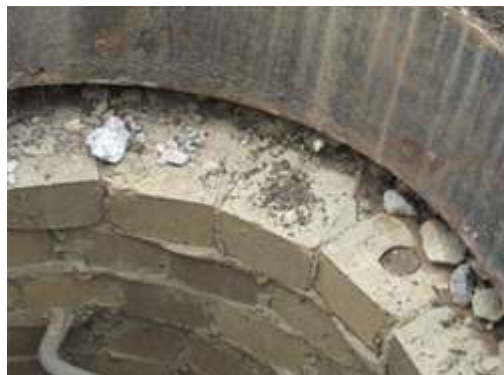
frame-chimney joint

gap between frame chimney

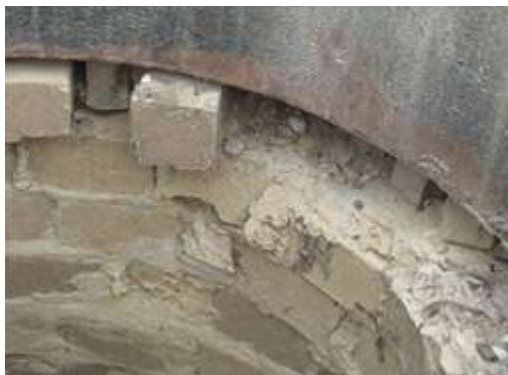
Defect 3

Condition: ☐ Sound ☐ Cracked ☐ Root Intrusion ☒ **Loose Brick** ☐ Deteriorated

missing loose bricks

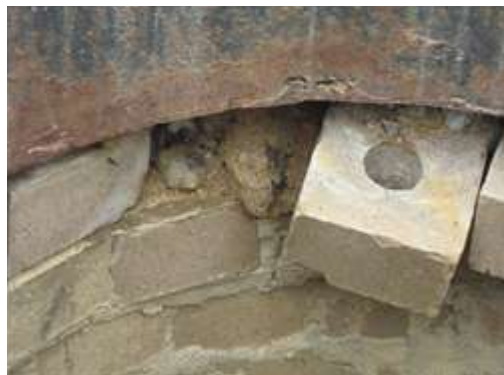
Defect 2

loose bricks

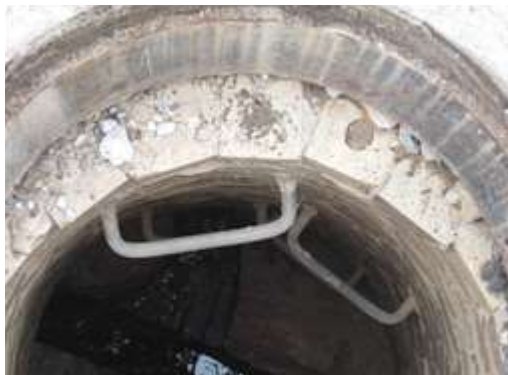
Defect 1

Offset: **3** (in.)

offset

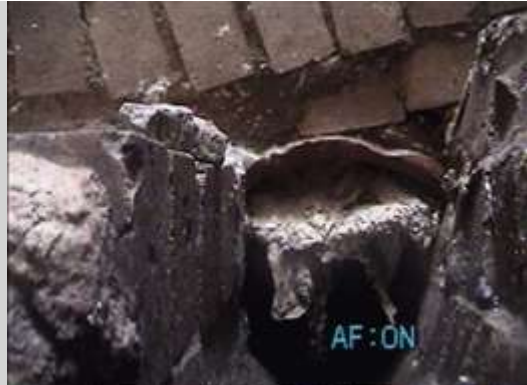
12 O'Clock Outflow

12 oclock pipe looks to be broken

Infiltration: **Evidence** Pipe Seal Cond: **Broken**

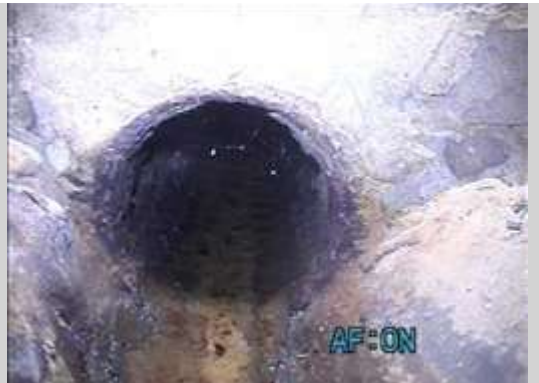
8 O'Clock Inflow

Infiltration: **Evidence** Pipe Seal Cond: **Unknown**
